Saltmarsh Restoration
Priorities for the
Saltmarsh Sparrow

New Jersey

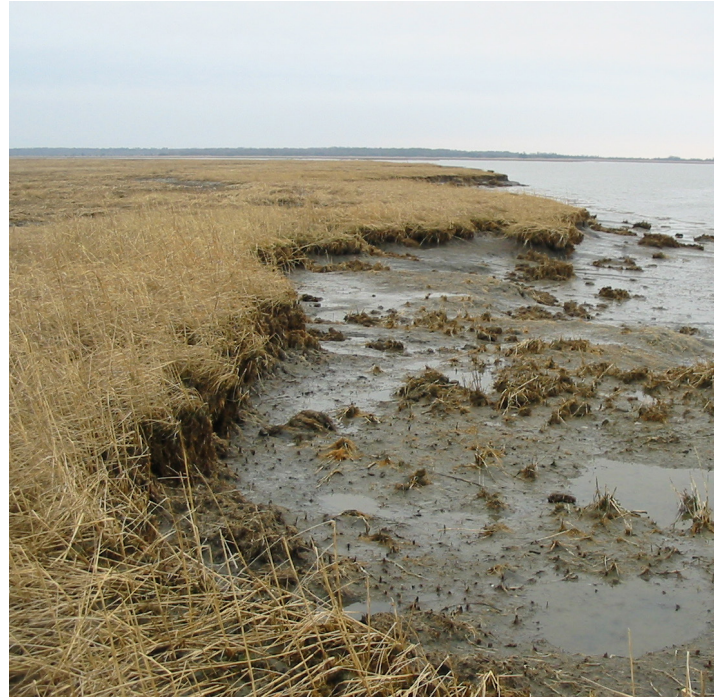
Salt marsh erosion along the Maurice River. Partnership for Delaware Estuary

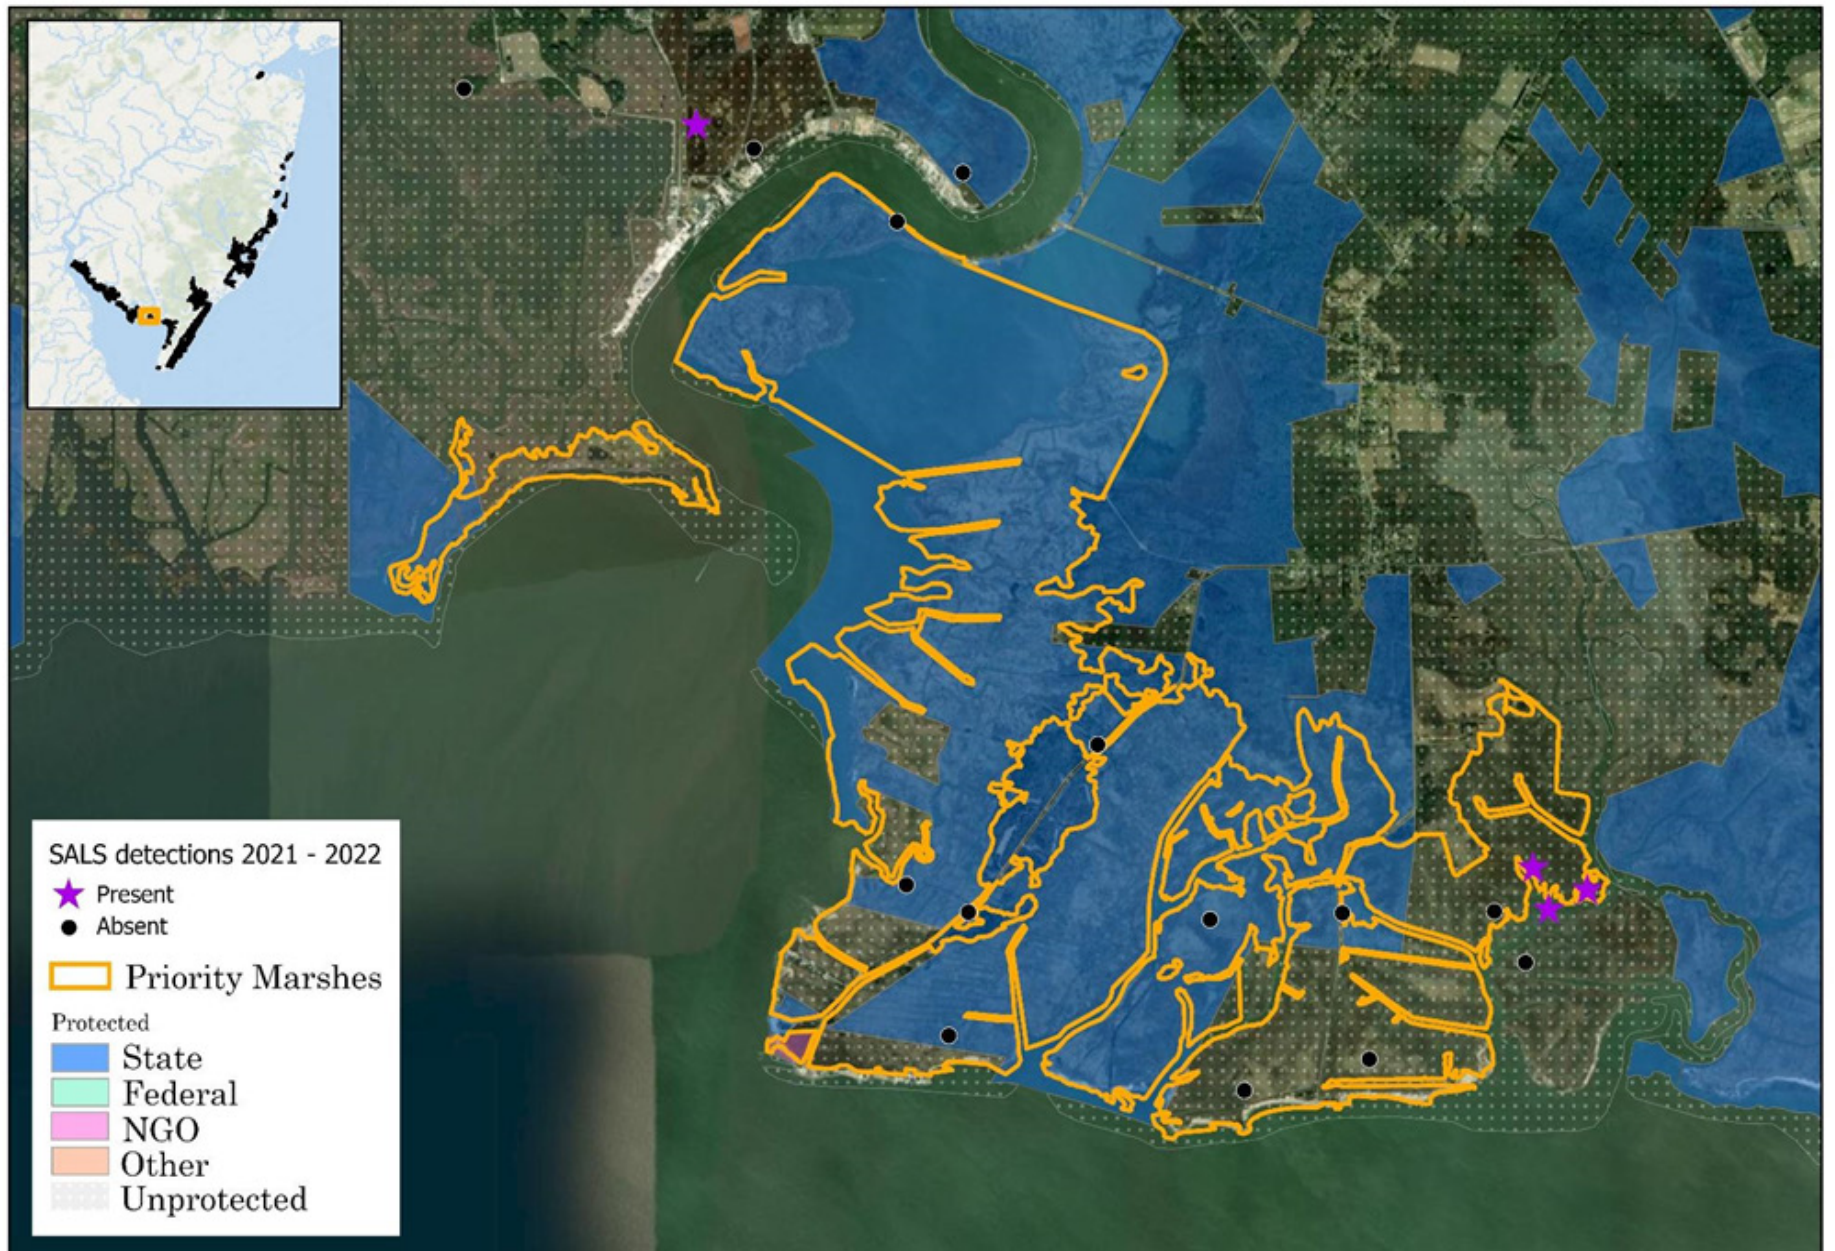
Maurice River / Heislerville WMA

The complex is made up of primarily low marsh with high marsh hummocks and has significant potential migration space surrounding it. Some high marsh occurs near East Point. Bad erosion on riverbanks.

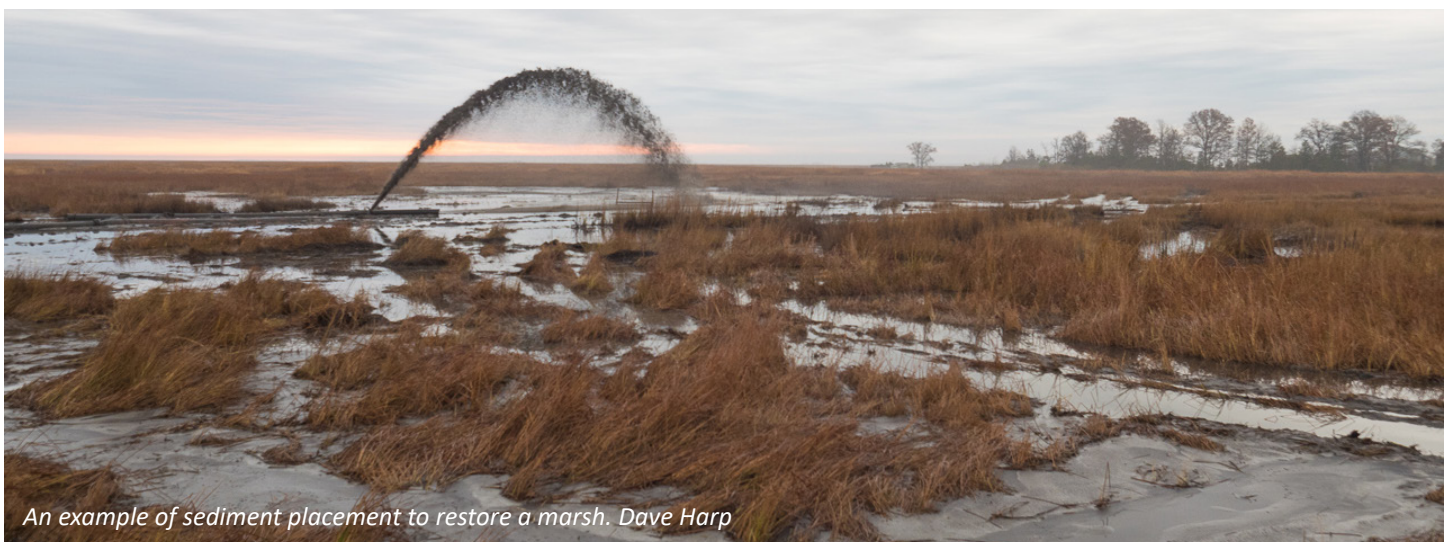
An example of sediment placement to restore a marsh. Dave Harp
