Saltmarsh Restoration
Priorities for the
Saltmarsh Sparrow

Rhode Island

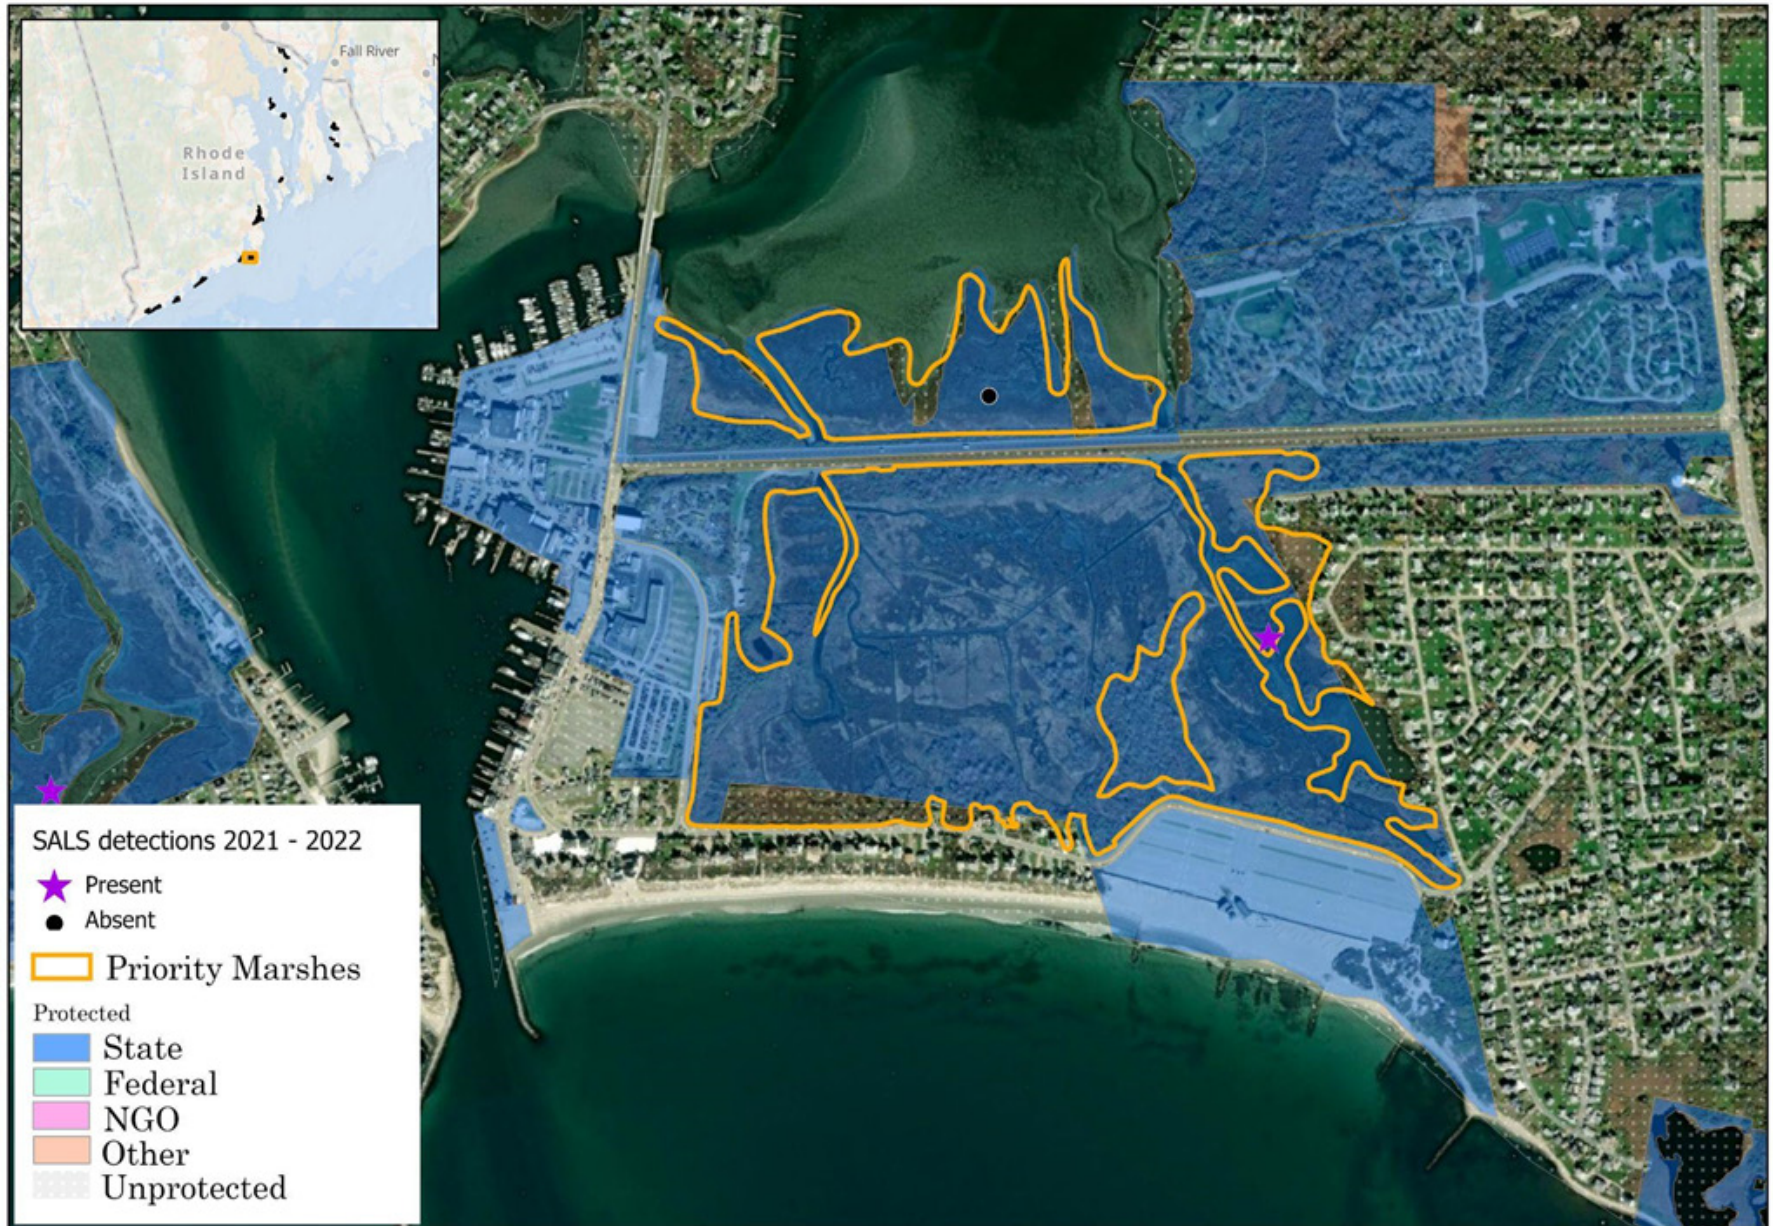
Galilee Marsh

Galilee salt marsh (Narragansett) is a 138-acre tidal wetland complex composed of a tidal creek, high marsh, and low marsh habitats managed for wildlife conservation and hunting by Rhode Island Department of Environmental Management (RIDEM). This system currently includes four self-regulating tide gates that were designed to restore salt marsh habitat by re-establishing tidal connectivity to Point Judith Pond while preventing flooding of adjacent residential development. Under current conditions, the marsh is receiving too much tidal flow and large agricultural embankments, former farm roads, and ditch spoils are further contributing to prolonged flooding of the marsh platform, which has led to vegetative die-off and marsh subsidence. Invasive *Phragmites australis* (hereafter *Phragmites*) is present, site has signs of extensive alterations, including ditches and agricultural berms.

- Elevation: Moderate (0.6 NAVD88)
- Disturbance: Moderate
- Index of Marsh Integrity: Intermediately degraded (6.6)
- Migration Potential: High relative to marsh size, but low priority statewide
- High quality high marsh: estimated 16% (inner) and 10% (outer) for a total of 20.5 acres.
- Estimated marsh loss (outer marsh only) = 17.6% (High) between 1972 and 2020

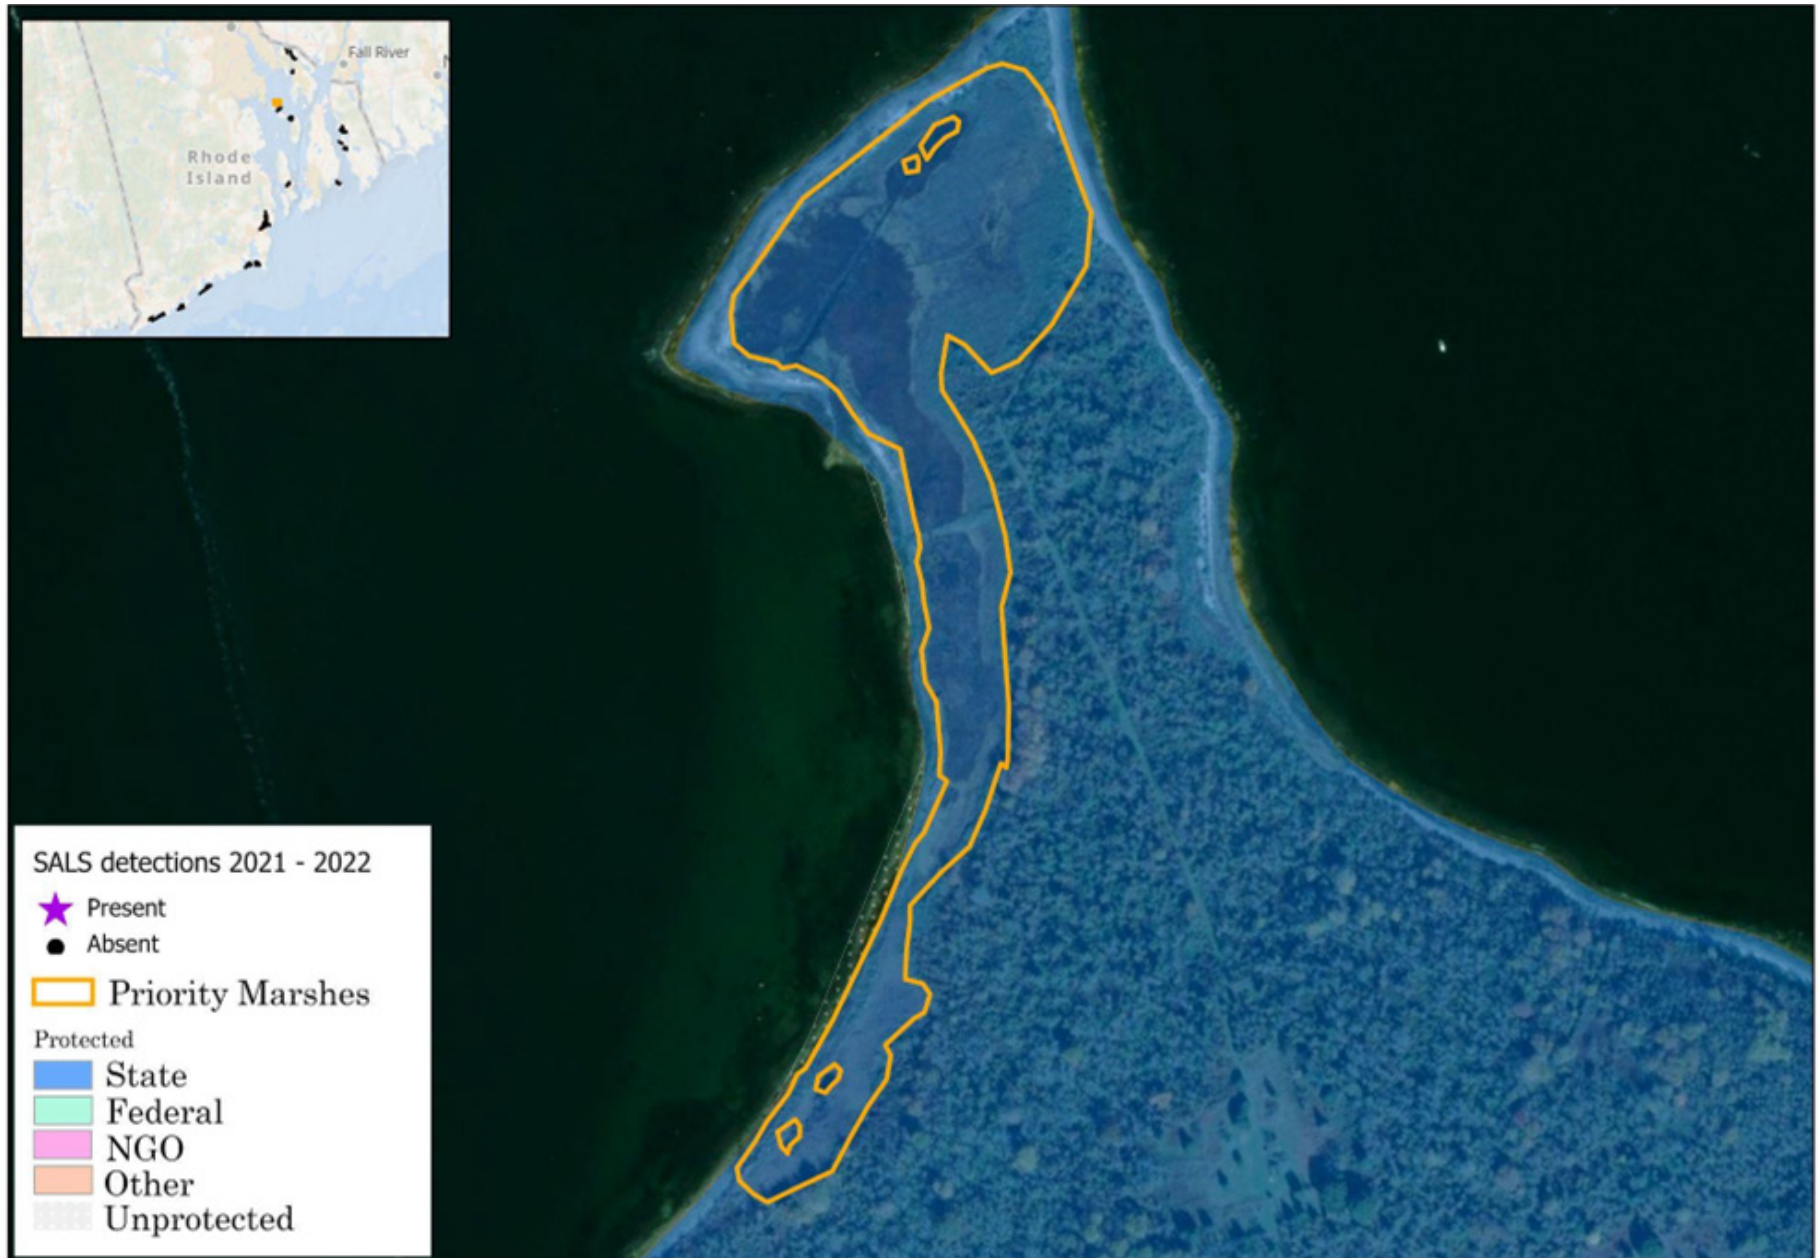
Prudence Island 'Providence Point'

This small site has a high proportion of high marsh and salt shrub habitat with no history of alterations. The northern portion of the site is in good condition; it consists largely of high marsh salt meadow and extensive *Iva frutescens*, with one remnant ditch. The southern arm of the marsh, however, is largely degraded; it consists of impounded pools and ponds and generally clogged hydrology. It is this southern section that could be the main focus of future hydrologic repairs.

- Elevation: Medium (0.64 NAVD88)
- Disturbance: Low
- Index of Marsh Integrity: Least Degraded (7.8)
- Migration Potential: High (salt shrub 36%)
- High quality high marsh – estimated at 25% currently (3.75 acres)
- Estimated marsh loss = 2.2 % (Low) between 1972 and 2020

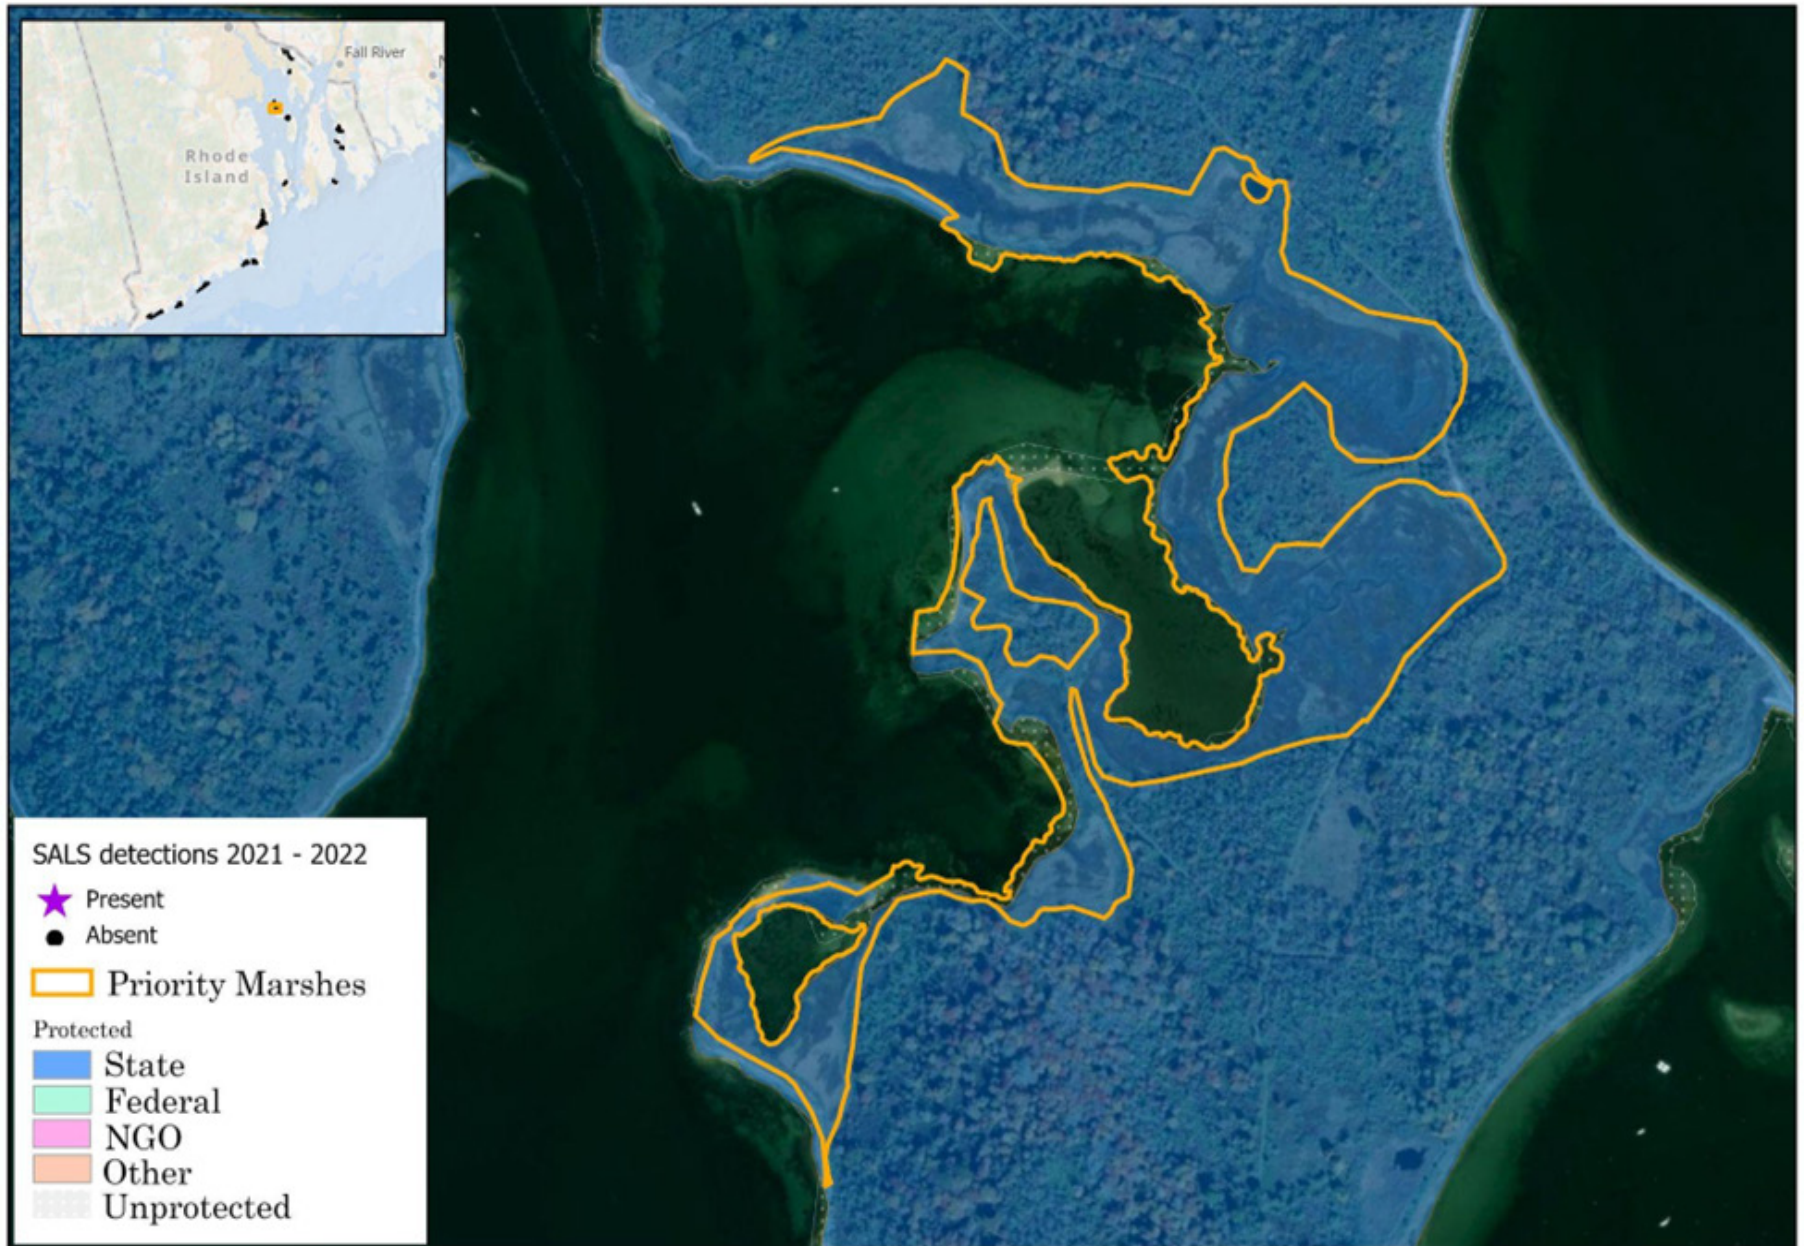
Prudence Island 'Coggeshall & Sheep Pen'

NERR: Previous restoration actions include extensive monitoring, research and management of Coggeshall as one of two NERR Sentinel Sites where long-term monitoring of vegetation, elevation, elevation change, water levels and migration rates is conducted. A short-term migration facilitation experiment was also recently completed at Sheep Pen. Support is still needed for design, permitting, implementation, and monitoring in this area. Best contact: Kenny Raposa (kenneth.raposa@dem.ri.gov)

- Elevation: Medium (0.62 NAVD88)
- Disturbance: Moderate
- Index of Marsh Integrity: Intermediate Degraded (6.1)
- Migration Potential: Moderate
- High quality high marsh: estimated at 11.7% currently (9.1 acres)
- Estimated marsh loss = 3.6% (Low) between 1972 and 2020

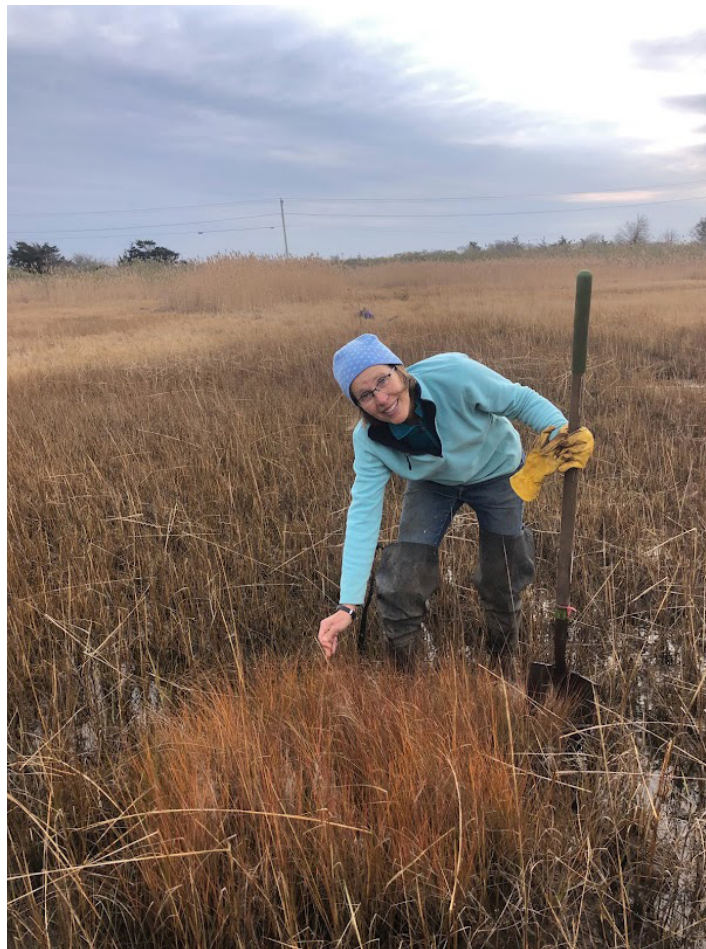
Wenley Ferguson of Save the Bay examines a small mound of peat from runnel excavation. Save the Bay

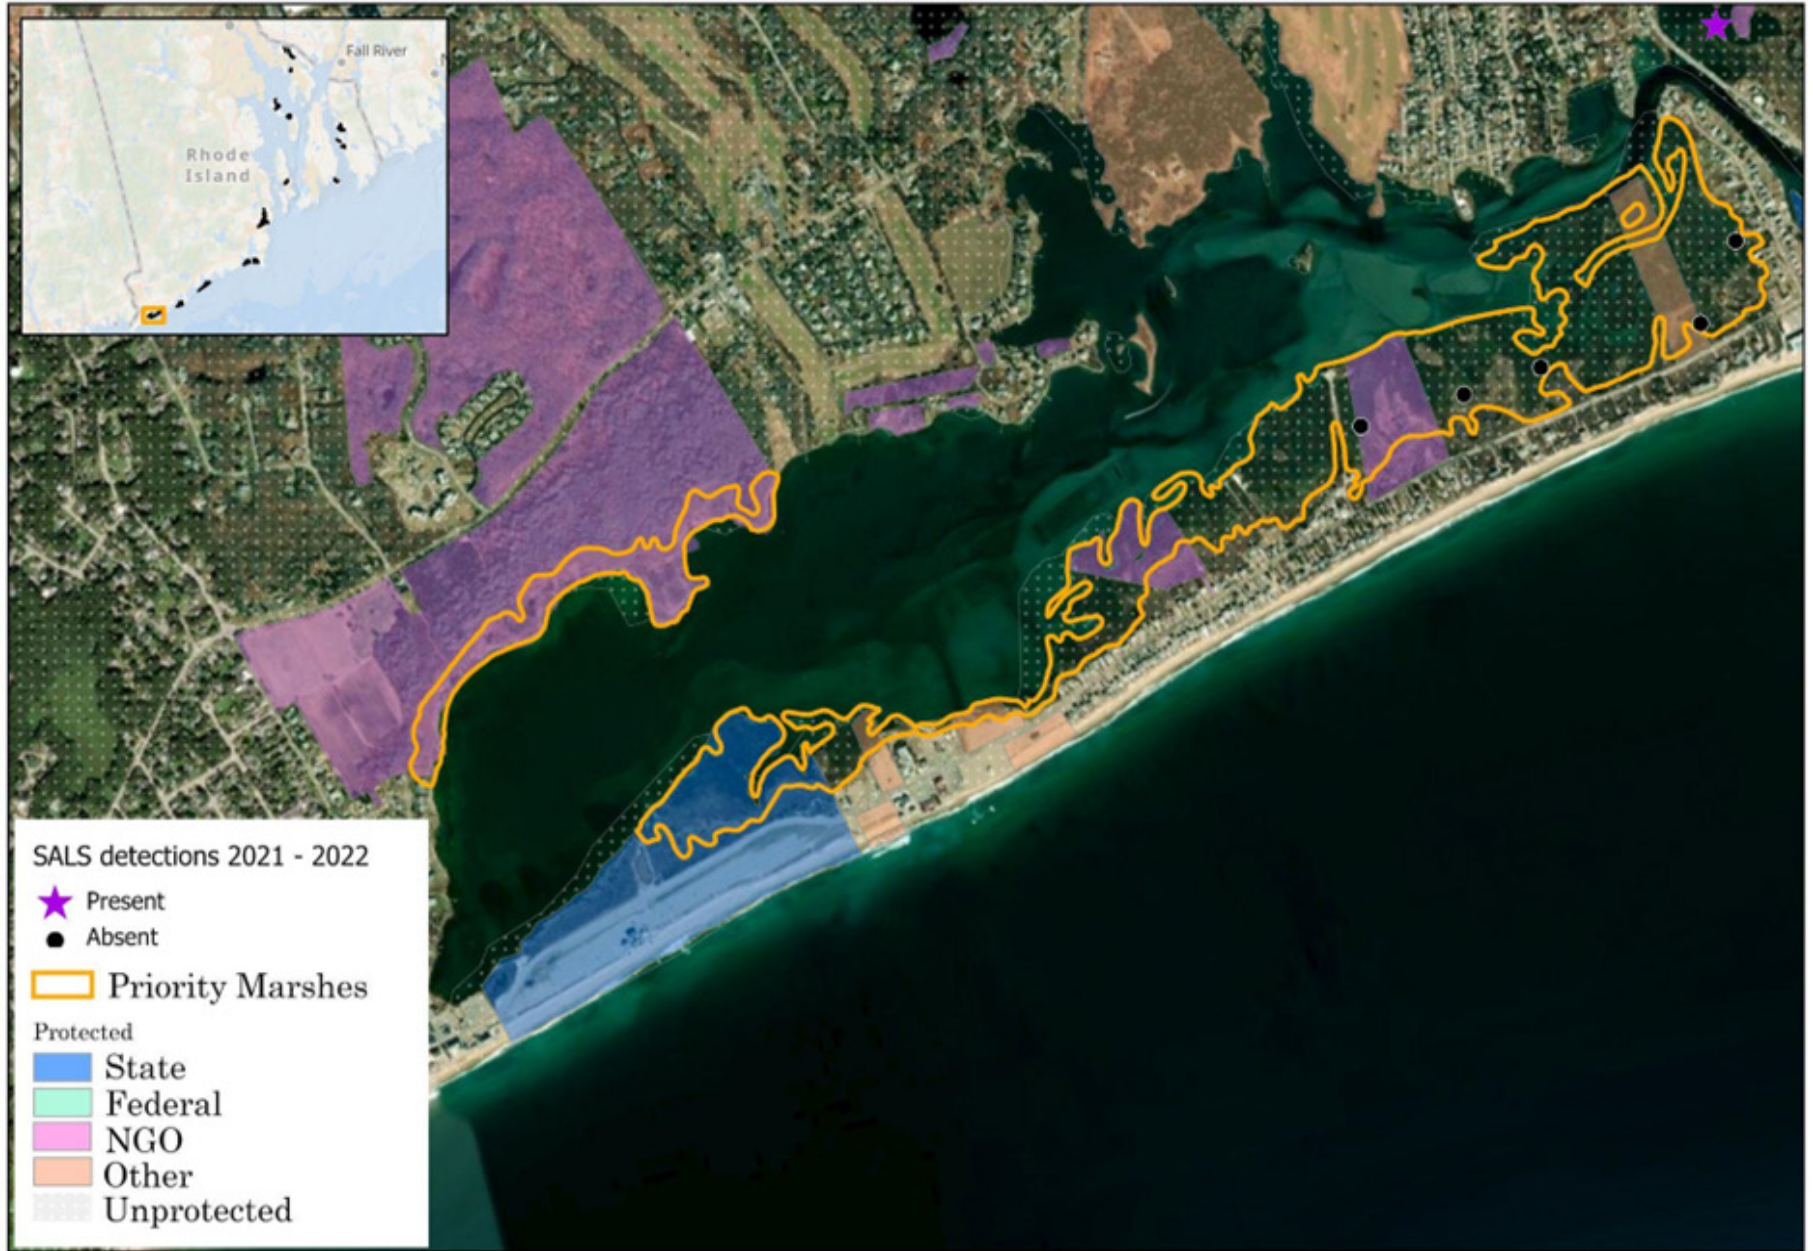
Winnapaug

Weekapaug Foundation for Conservation: 2017-18 3 separate parcels, funding through RI Coastal and Estuarine Habitat Restoration Trust Fund. Runnel installation and selective ditch maintenance in a highly impaired grid ditched marsh. Marsh migration facilitation through drainage improvements in areas where marsh migrating into the overwash areas.

- Elevation: Low (0.13 NAVD88)
- Disturbance: Low
- Index of Marsh Integrity: Most Degraded (4.9)
- Migration Potential: Low
- High quality high marsh – estimated at 5.2 % currently (8 acres)
- Estimated marsh loss = 14.6% (High) between 1972 and 2020

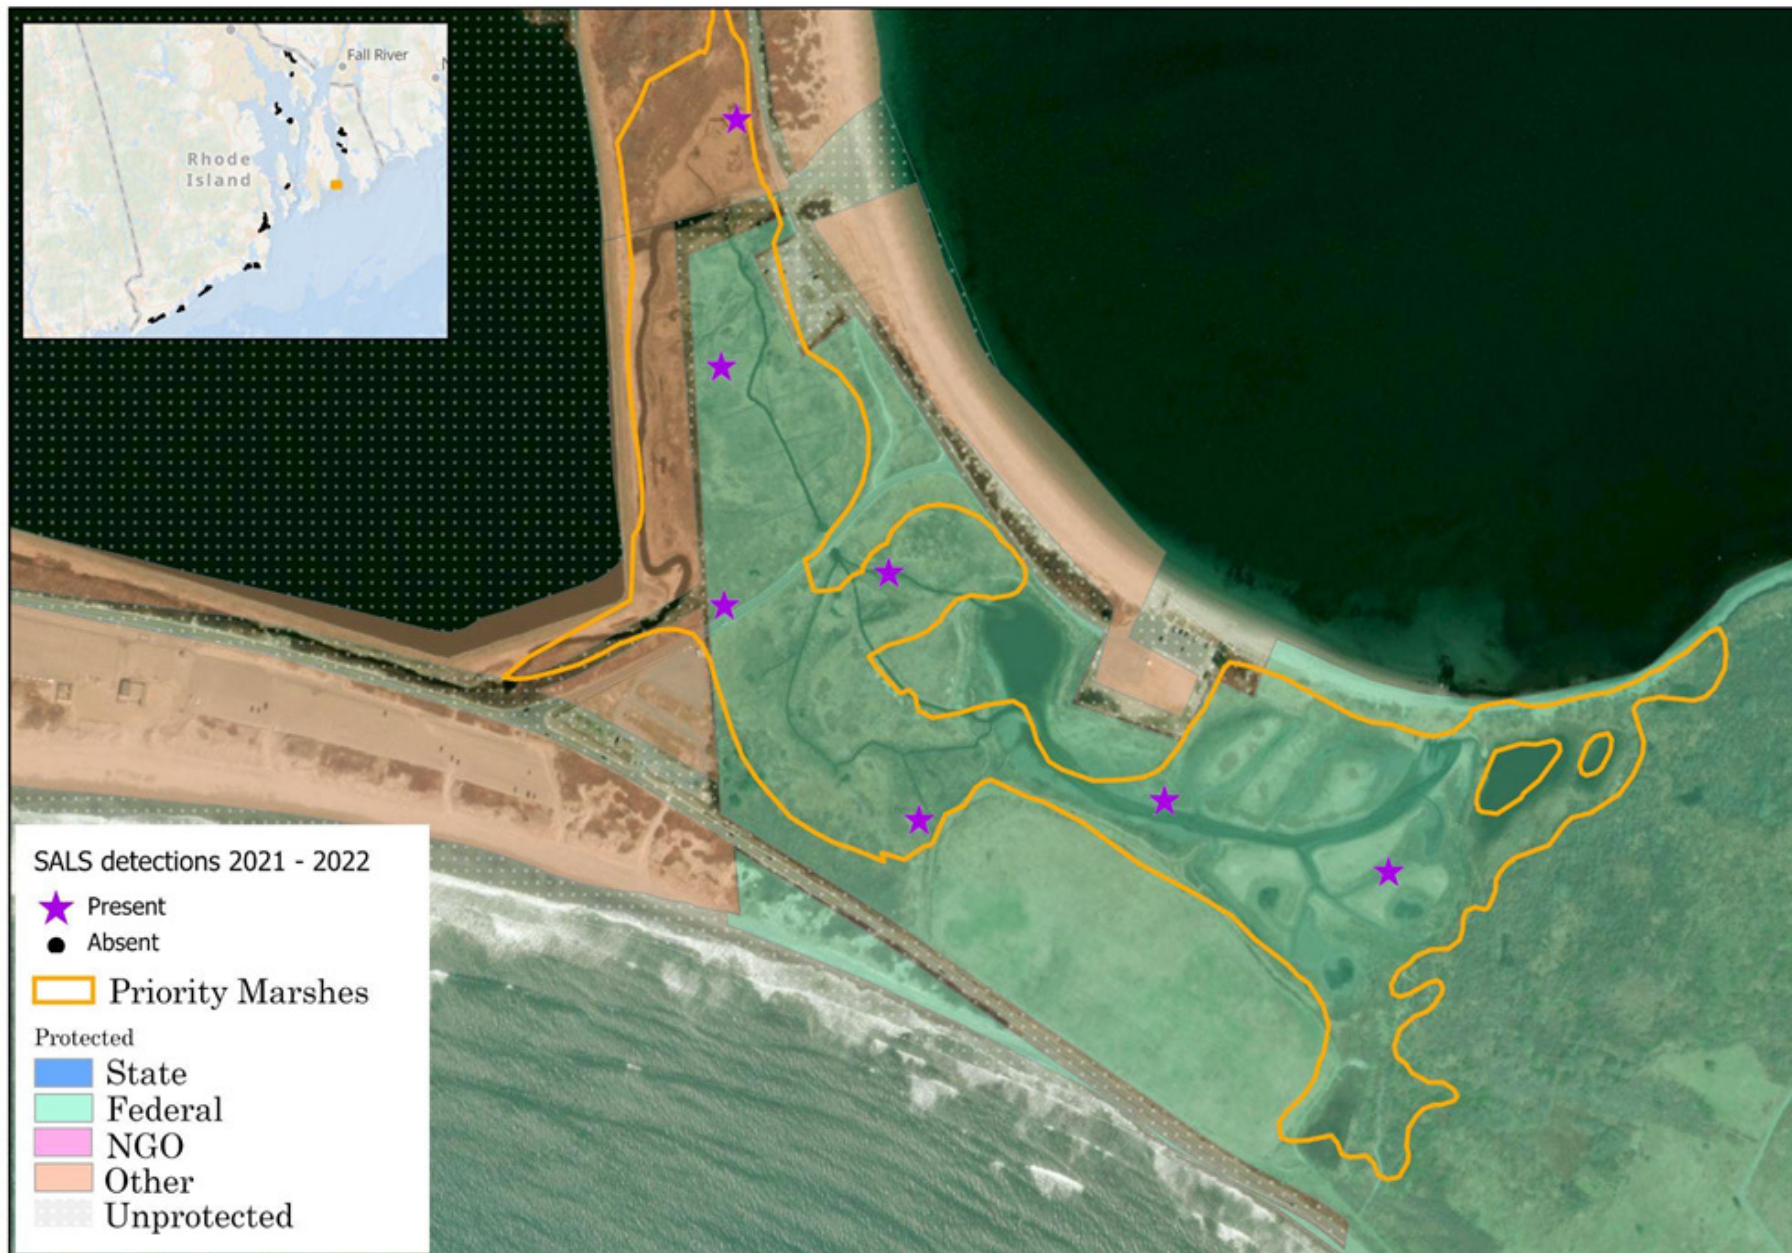
Sachuest Marsh (Middletown) is a highly manipulated salt marsh owned by USFWS (Sachuest NWR) and the Norman Bird Sanctuary. The outlet of this marsh was moved in the late 1800s when a water supply was created in the former brackish and freshwater wetlands adjacent to the marsh. The marsh has suffered from flooding due to the manmade outlet that regularly became clogged with beach sand. A section of the marsh was historically used as a landfill by the Navy and the town. USFWS has conducted multiple restoration projects over the past 18 years to improve marsh health, including resizing a culvert, removing fill from the former landfill area and installing a new outlet to Narragansett Bay, and conducting an elevation enhancement project at part of the site in 2016. The marsh has been so highly modified that restoring the marsh to previous hydrology is very challenging. Existing conditions now include excessive freshwater input from diverted streams, impounded water on the marsh platform due to the combination of a bisecting road, altered flow paths (a result of previous attempts at restoration), and channels potentially restricting tidal flow and impeding drainage of freshwater during rain events (Maidford River). Engaged partners include USFWS, Norman Bird Sanctuary, and Save the Bay.

- Elevation: Moderate (0.5 NAVD88)
- Index of Marsh Integrity: Least degraded (7.8)
- Migration Potential: High (salt shrub = 58%)
- High quality high marsh: estimated at 8% (4 acres)
- Estimated marsh loss = unknown
